## DAM INSPECTION CHECKLIST POSSUM POINT POWER STATION POND ABC

INSPECTION DATE:	1/22/15
WEATHER: 81°F, A	Few Clouds
INSPECTED BY: D. WU	L. K. Homza

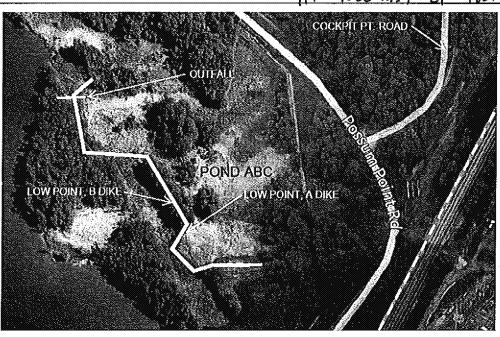
\* See figure below.

Location/		Change	
Condition	(y/n)	(y/n)	Comments
Low Point, A dike*			
Flow	7	٨	1012 hrs. No standing water behind sand bagger
Erosion	4	W	1012 hrs. No standing water behind sand bagged area. Sand bags and rip ray in place.
Low Point, B dike*			
Flow	·N	٣	1016 hrs. Wo standing water leting sand bagged
Erosion	N	N	area. Sand bags and rio ray in place.
Outfall			
water surface El.			1020 hrs. We standing water of concrete weir.
(top of stoplogs to water)			1020 hrs. No Standing water at concrete wein. Water is slightly seeping into NW corner of wein. 47" from ground to top of wein.

Additional Comments (Note any changes observed along the embankment crest or downstream slope observed from the crest.): kainfall event of 1.53" beginning 4119 ~2330 hrs and ing 4121 ~0800 hrs. Standing water at base of the slope between X and B.
